## **REPAIR OF FIRE-RATED GYPSUM PANEL PRODUCT SYSTEMS (GA-225-08)**

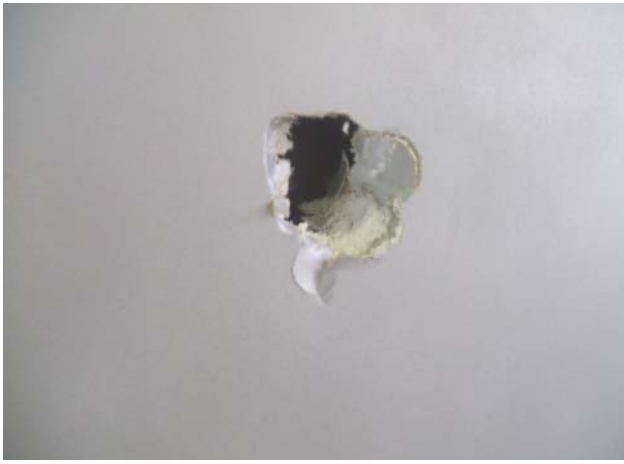
**Figure 1. Damaged Gypsum Board**
